Balboa Islands Seawall Rehabilitation Project

Rehabilitation Options

City Council Study Session
July 14, 2015

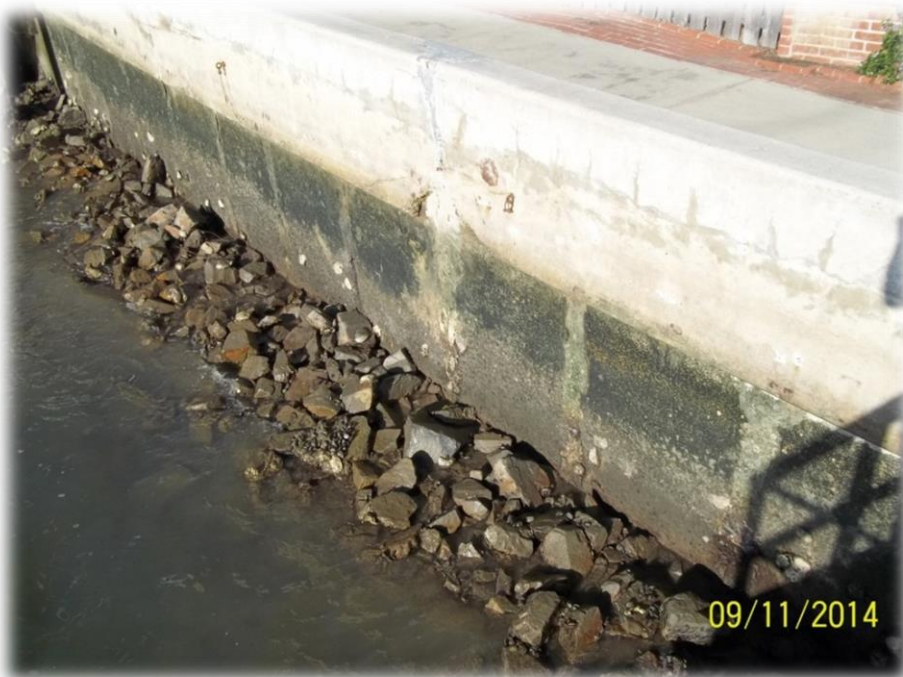
Rock Ballast Placed at
West End for Support
(1985)

Rock Ballast Replaced
at Corners of Grand
Canal and Little Island
for Support (~2000)

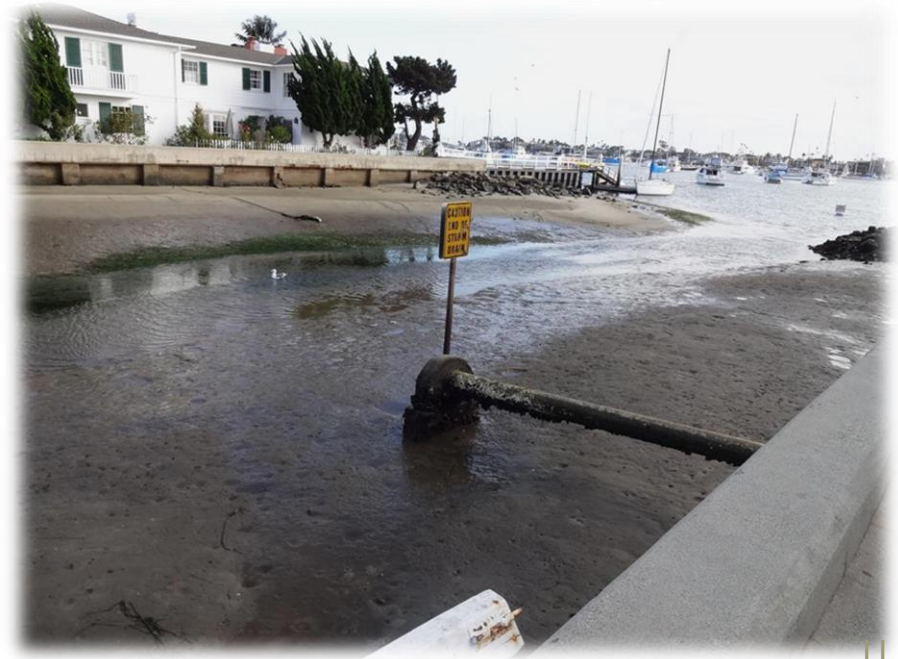
Earth Anchors installed E/o Balboa Island Ferry Landing - South Bay Front (1987)

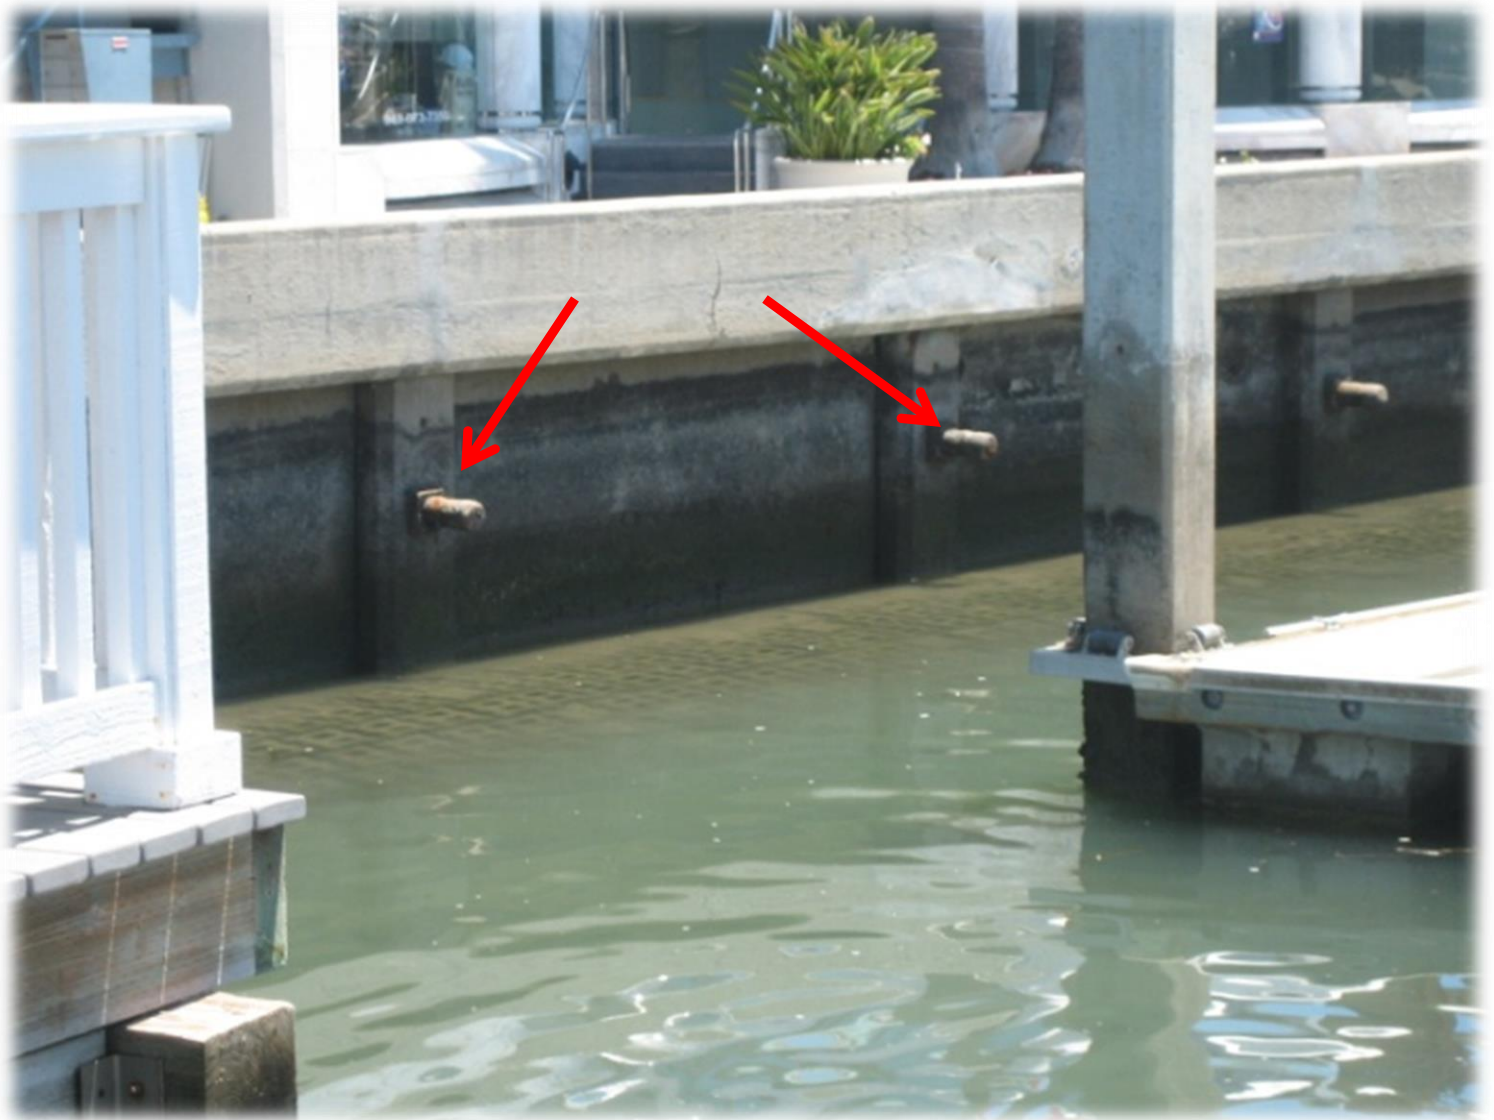
Pile Cracks (West End)

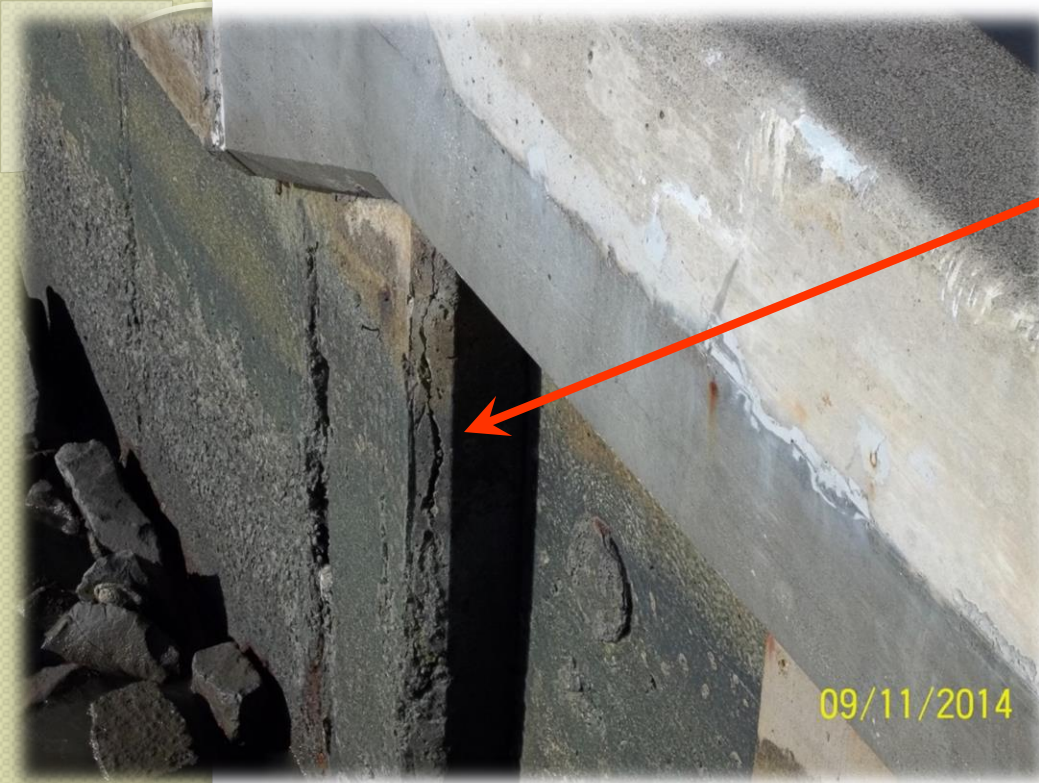
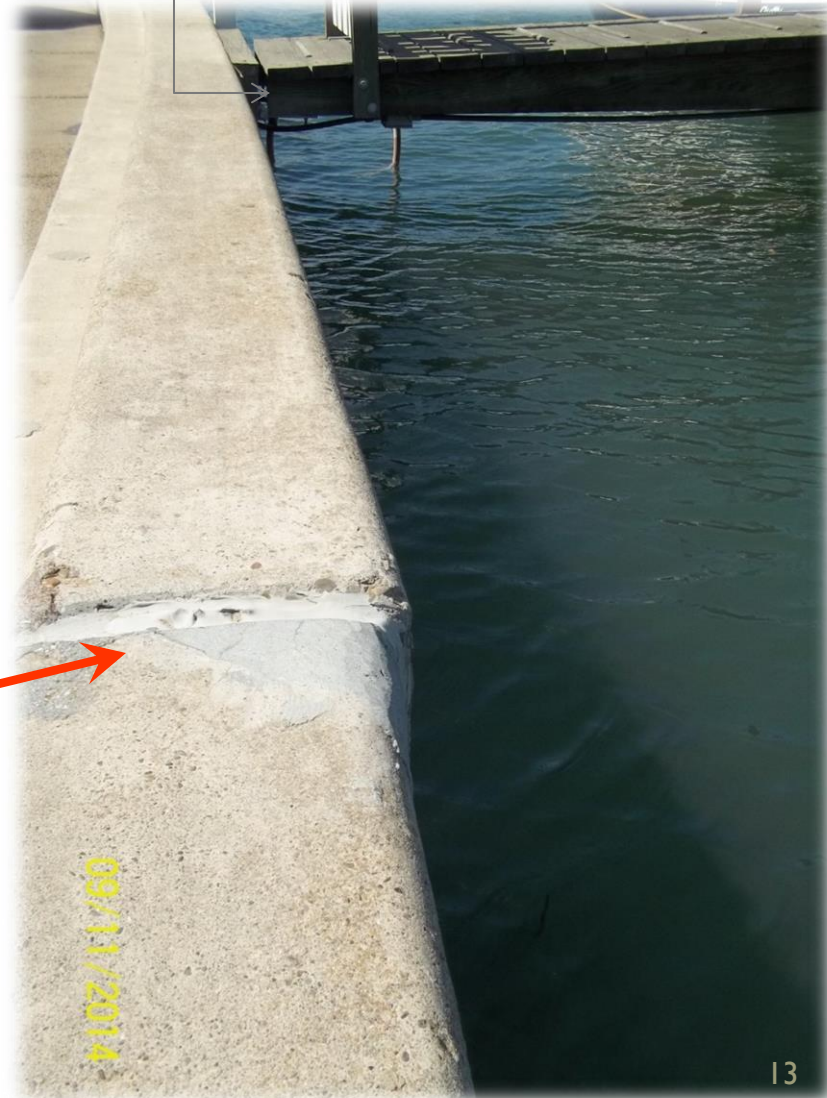
Wall Movement
(West End)

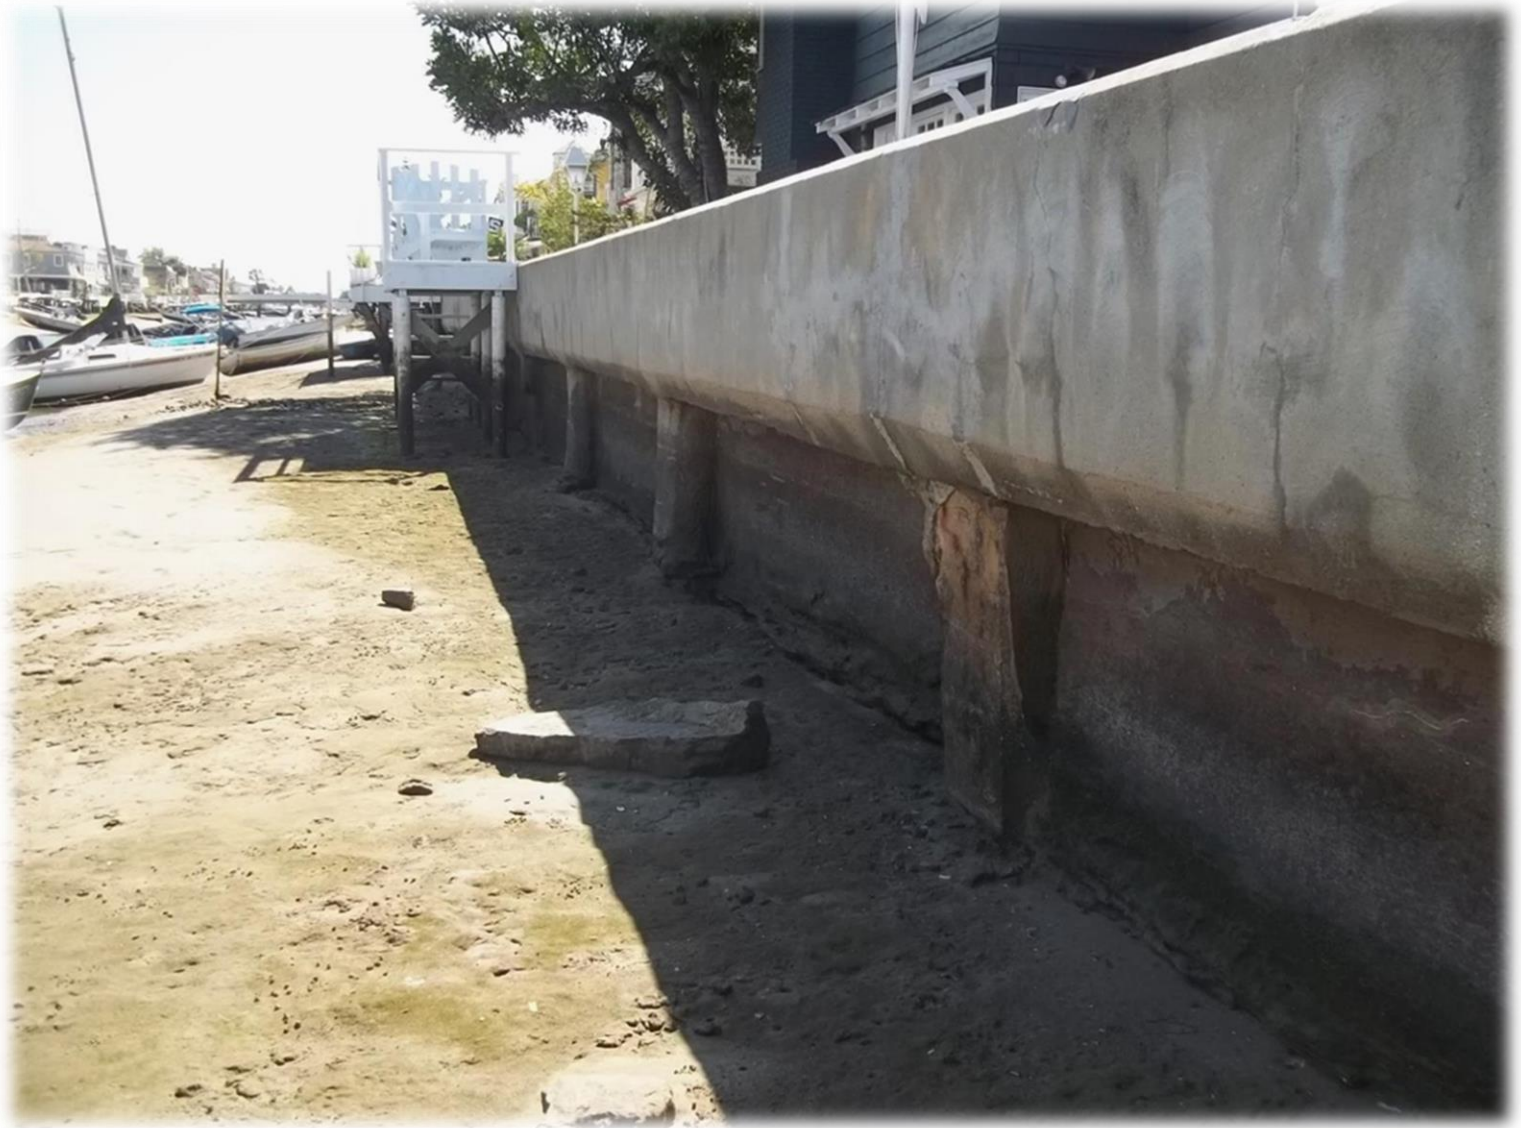
Grand Canal: Spalling Veneer

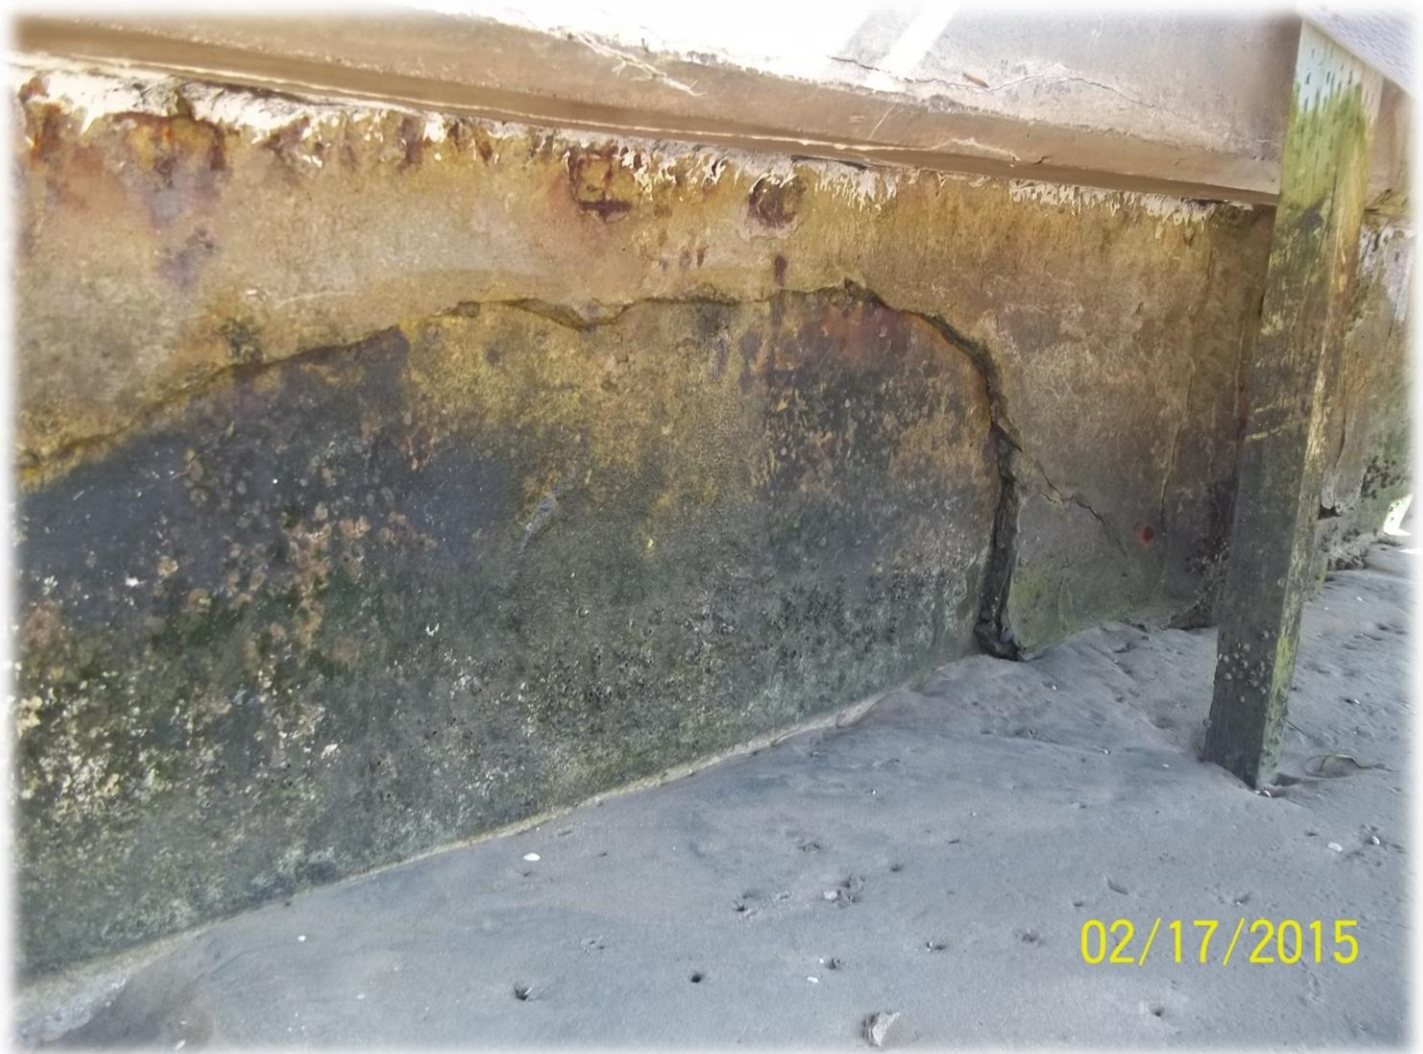
Grand Canal: Spalled Veneer

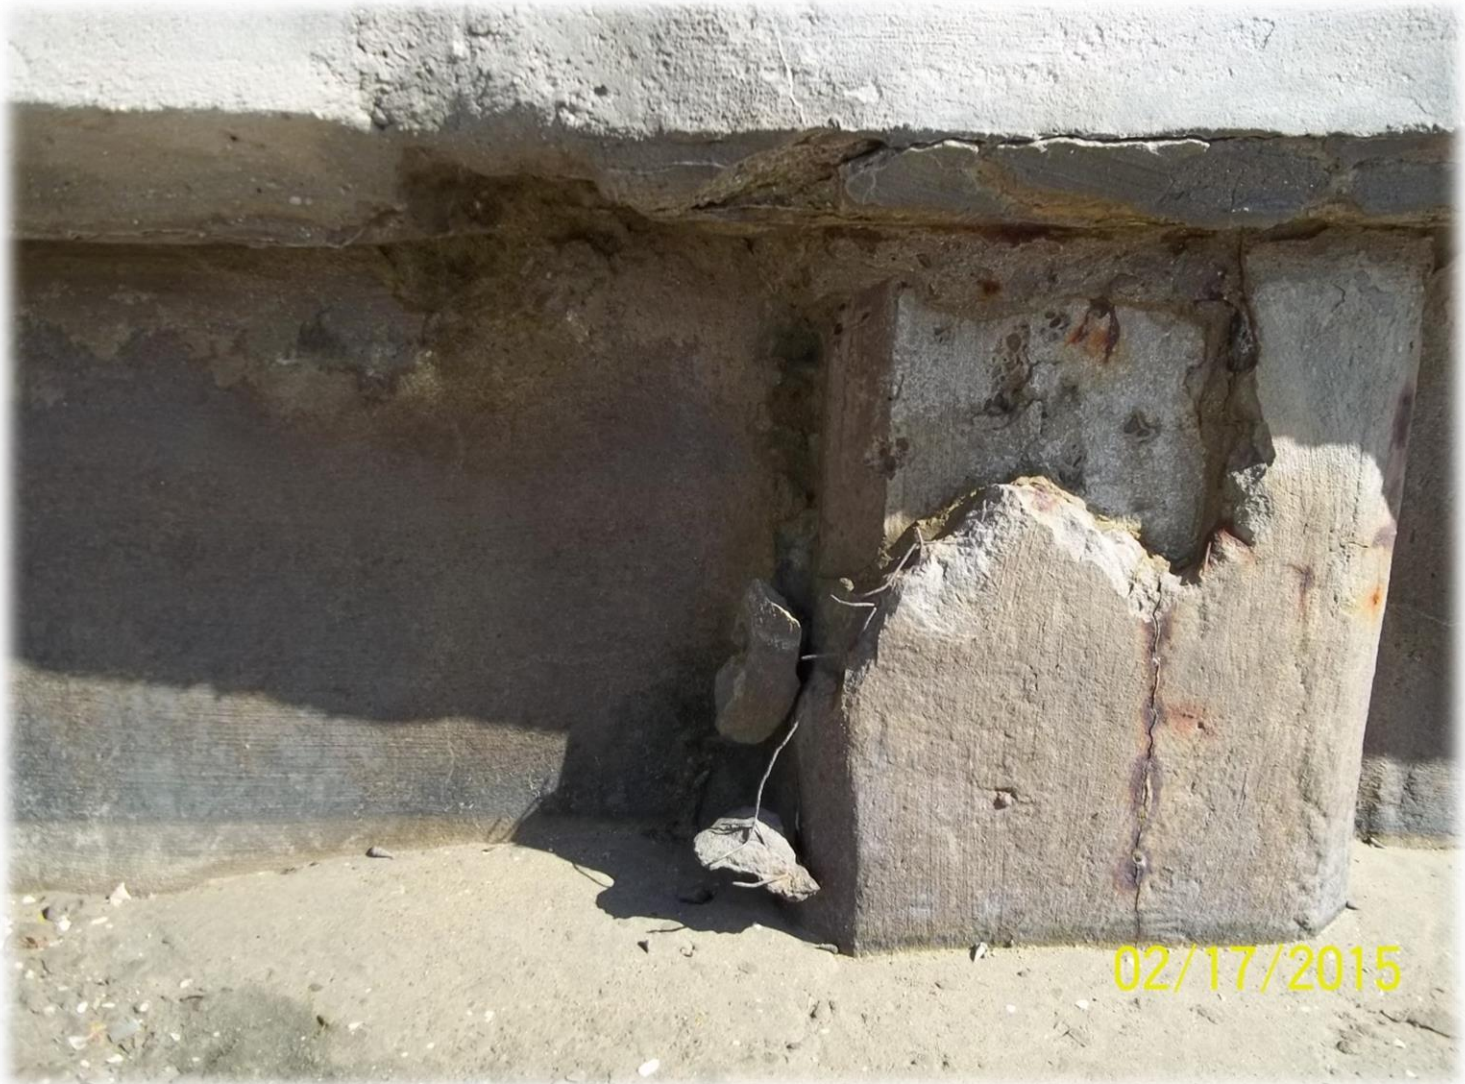
Grand Canal: Spalled Veneer on Soldier Pile

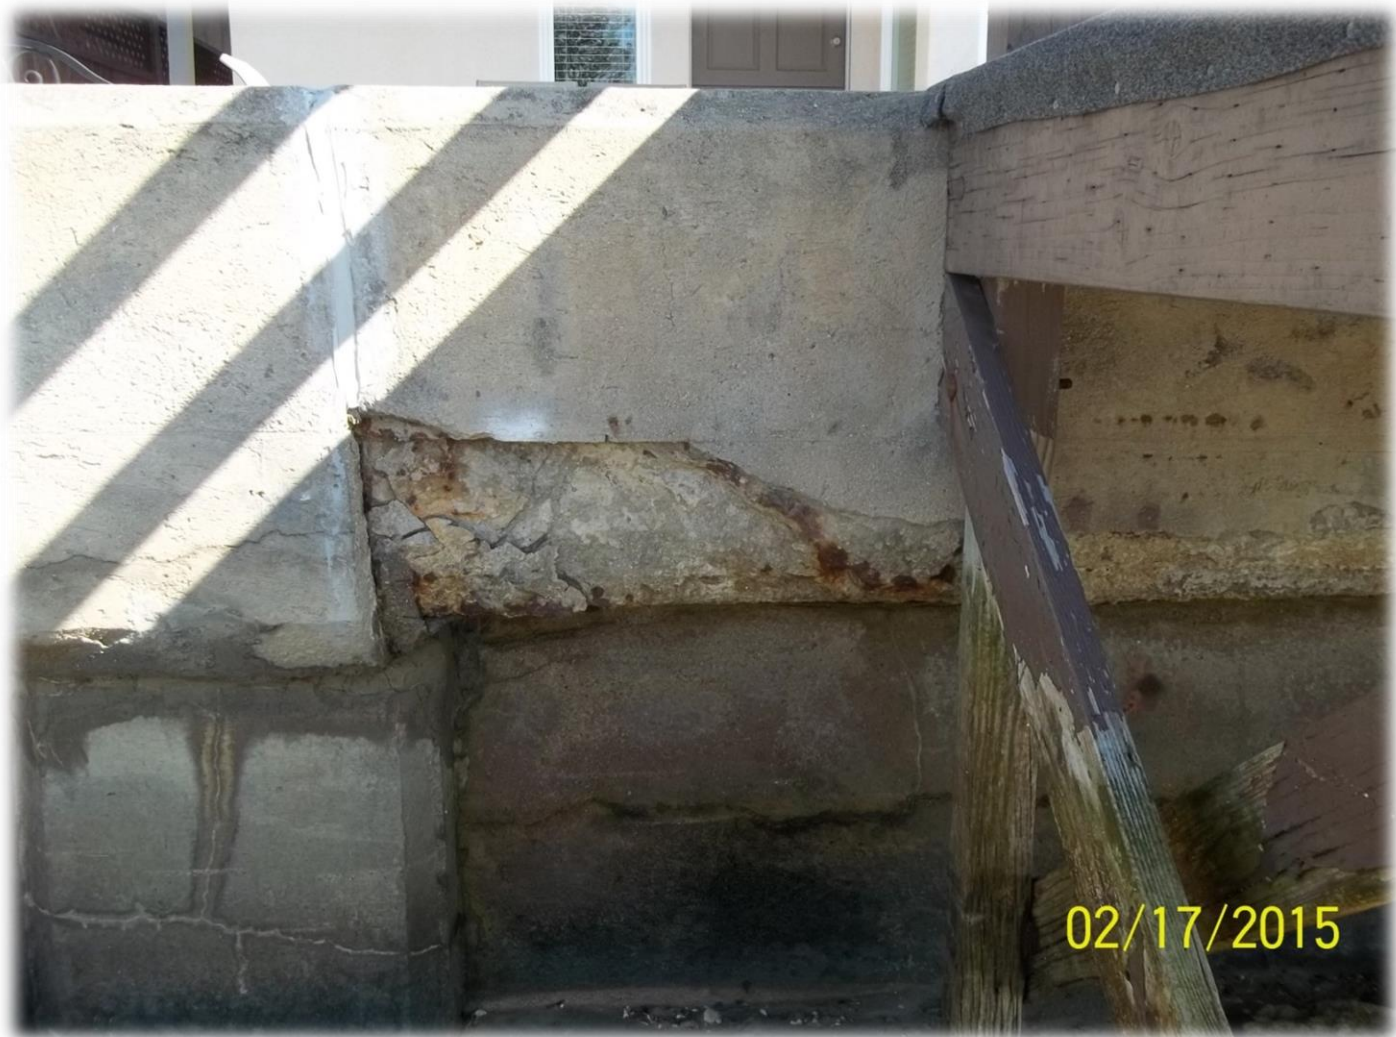
Grand Canal: Cap Veneer Spalled

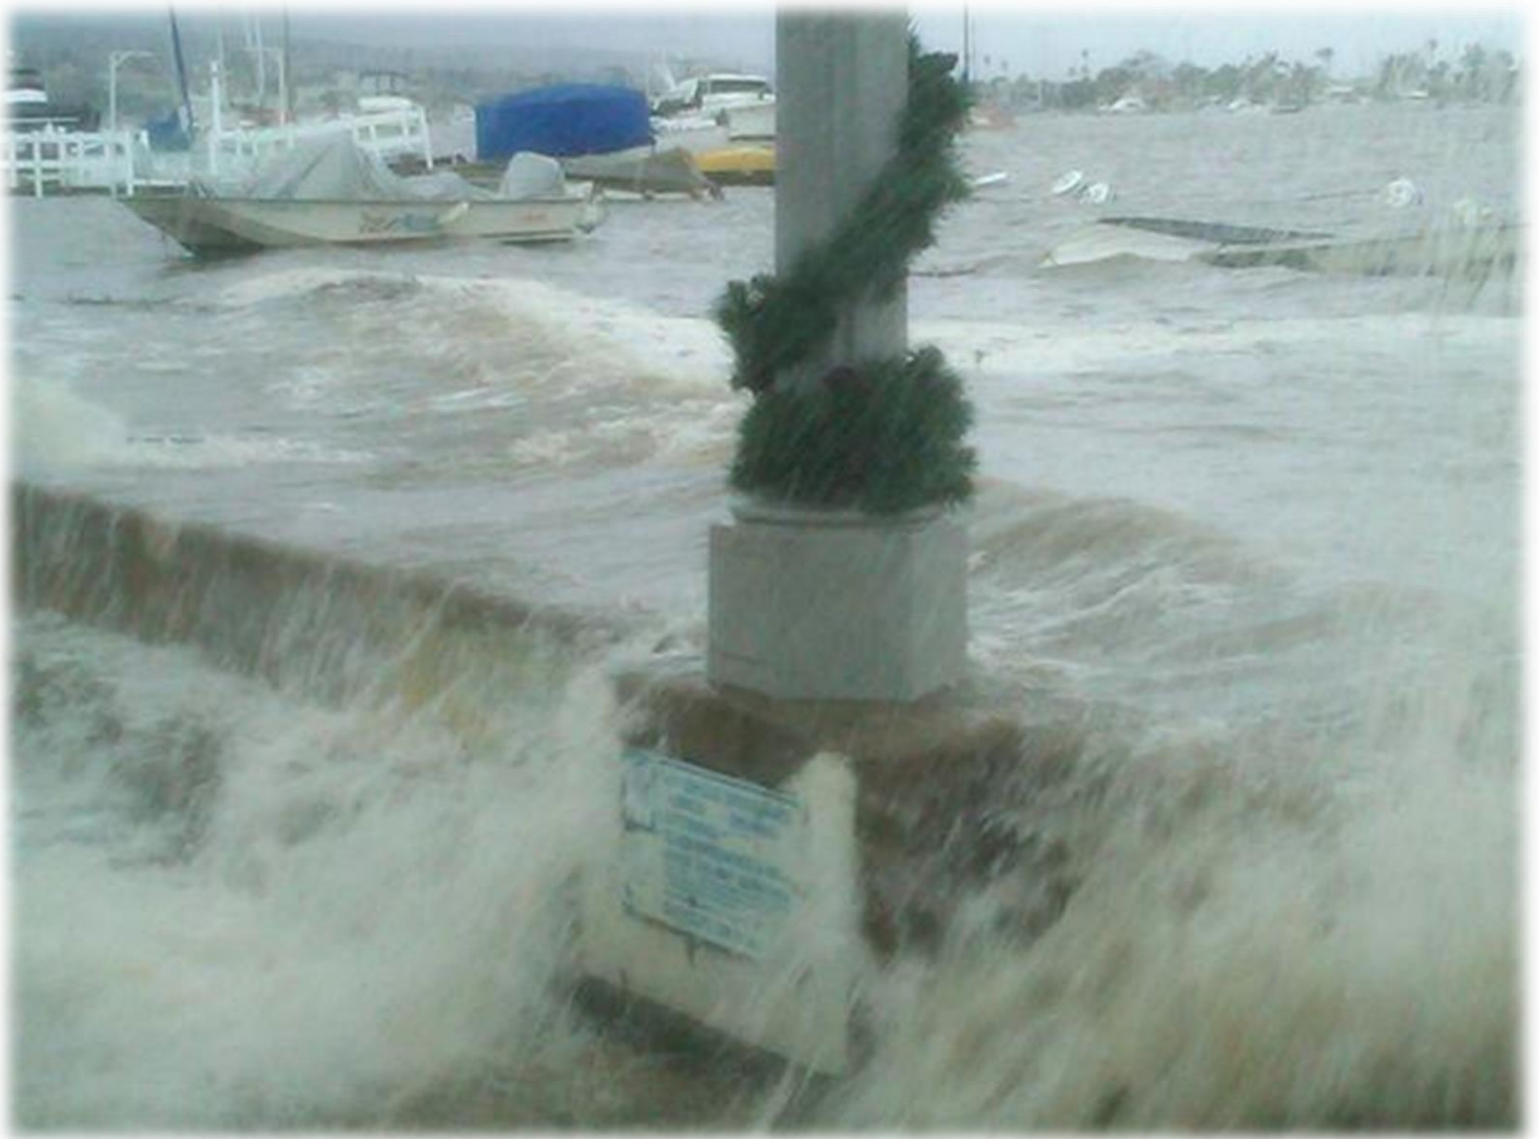
Overtopping Due To Storm Surge

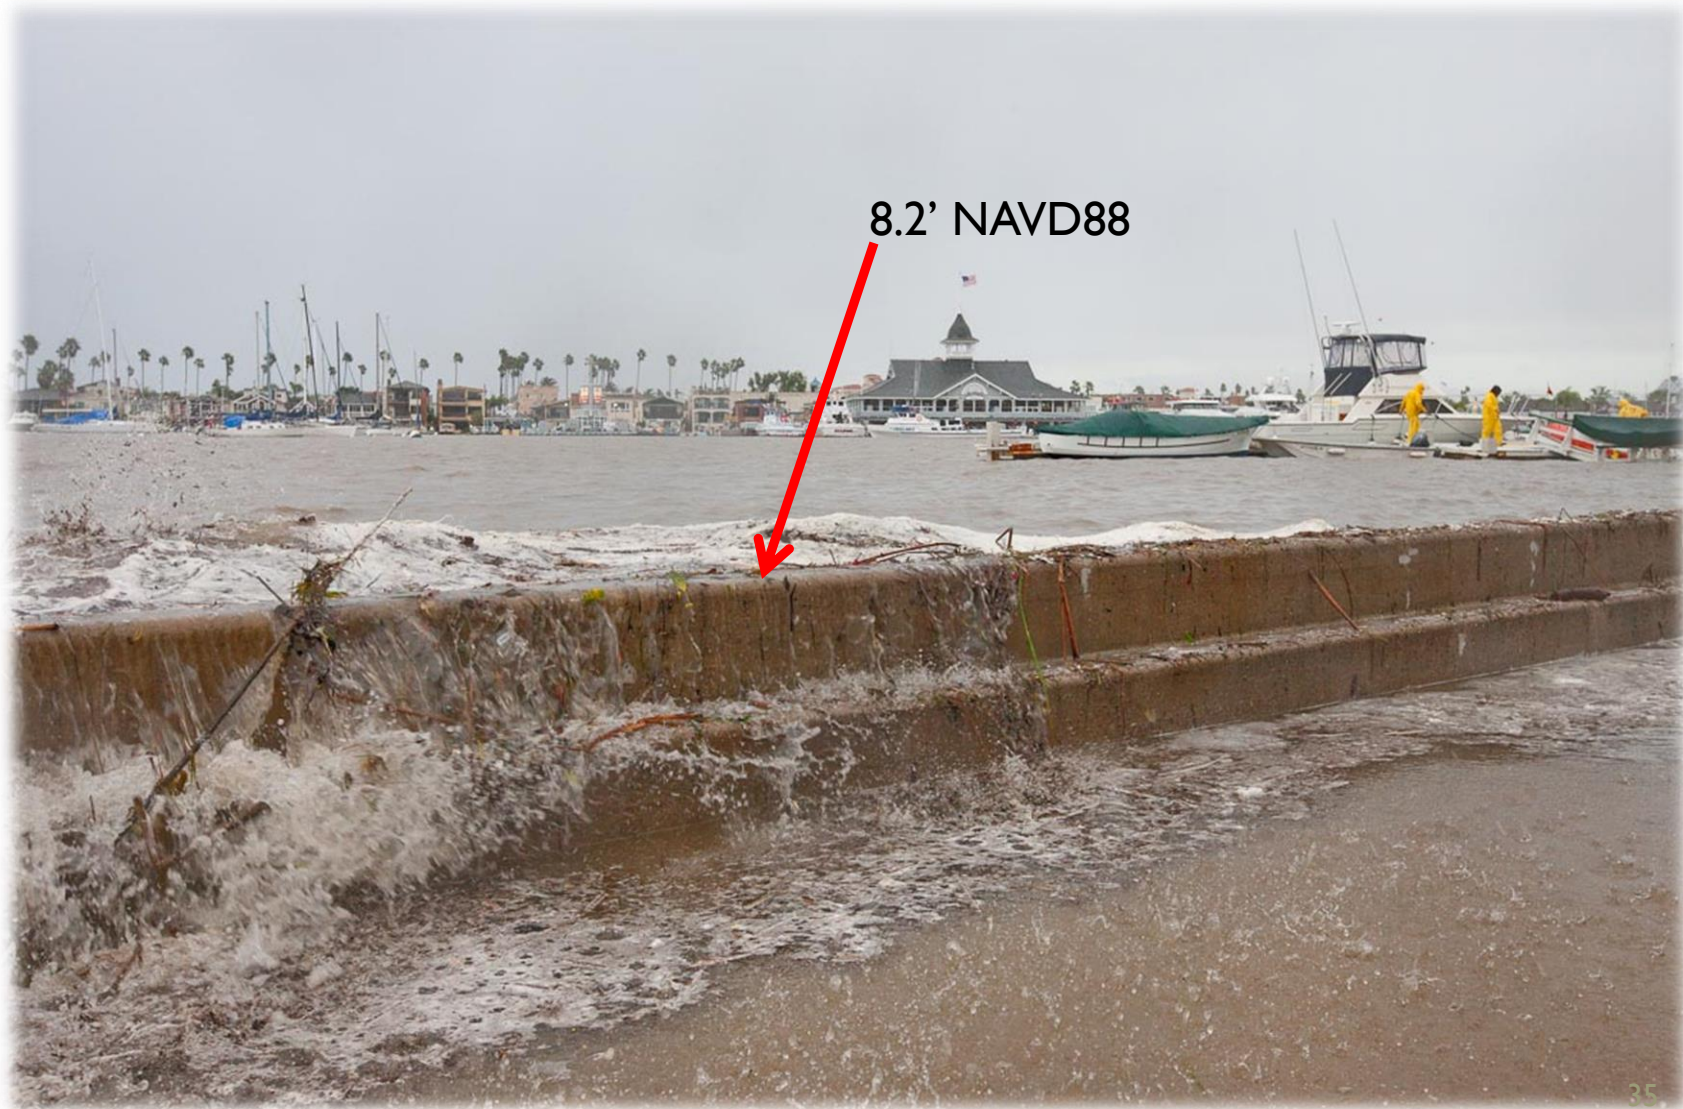
Overtopping Due To High Tides and Wind/Boat Waves (South Bay Front, 2010)

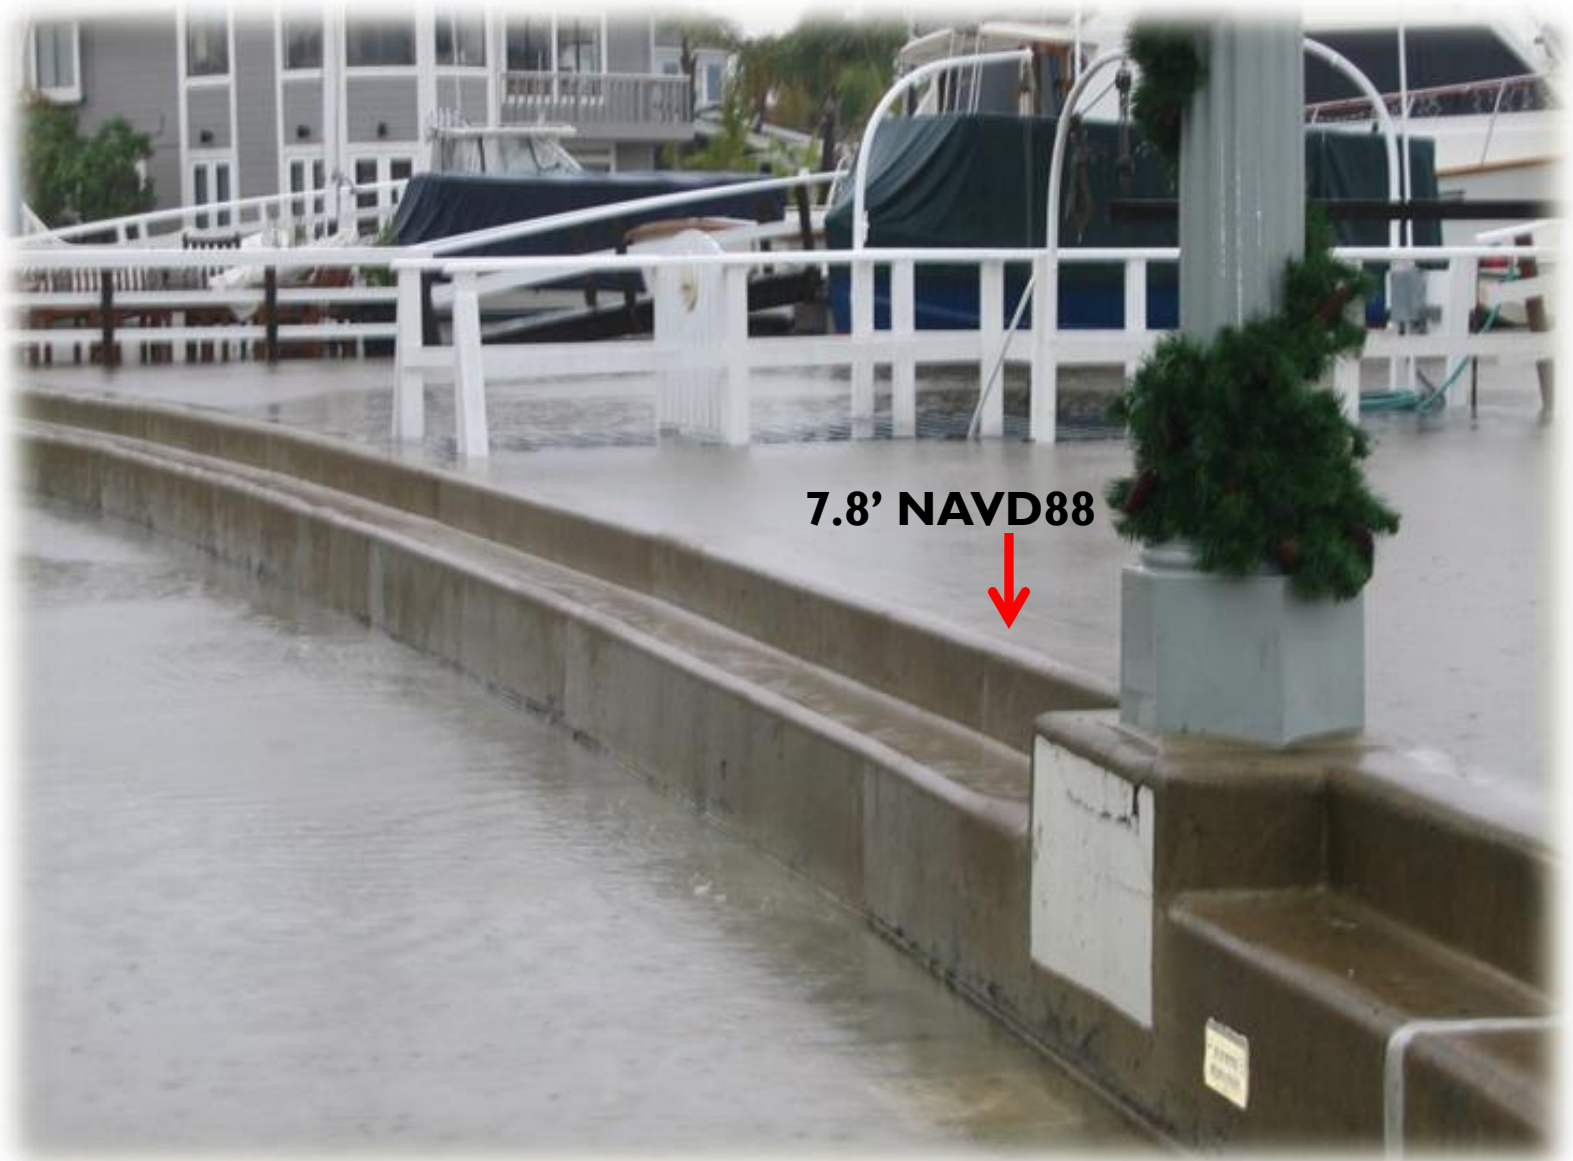
Hide Tide at north West End (2005)

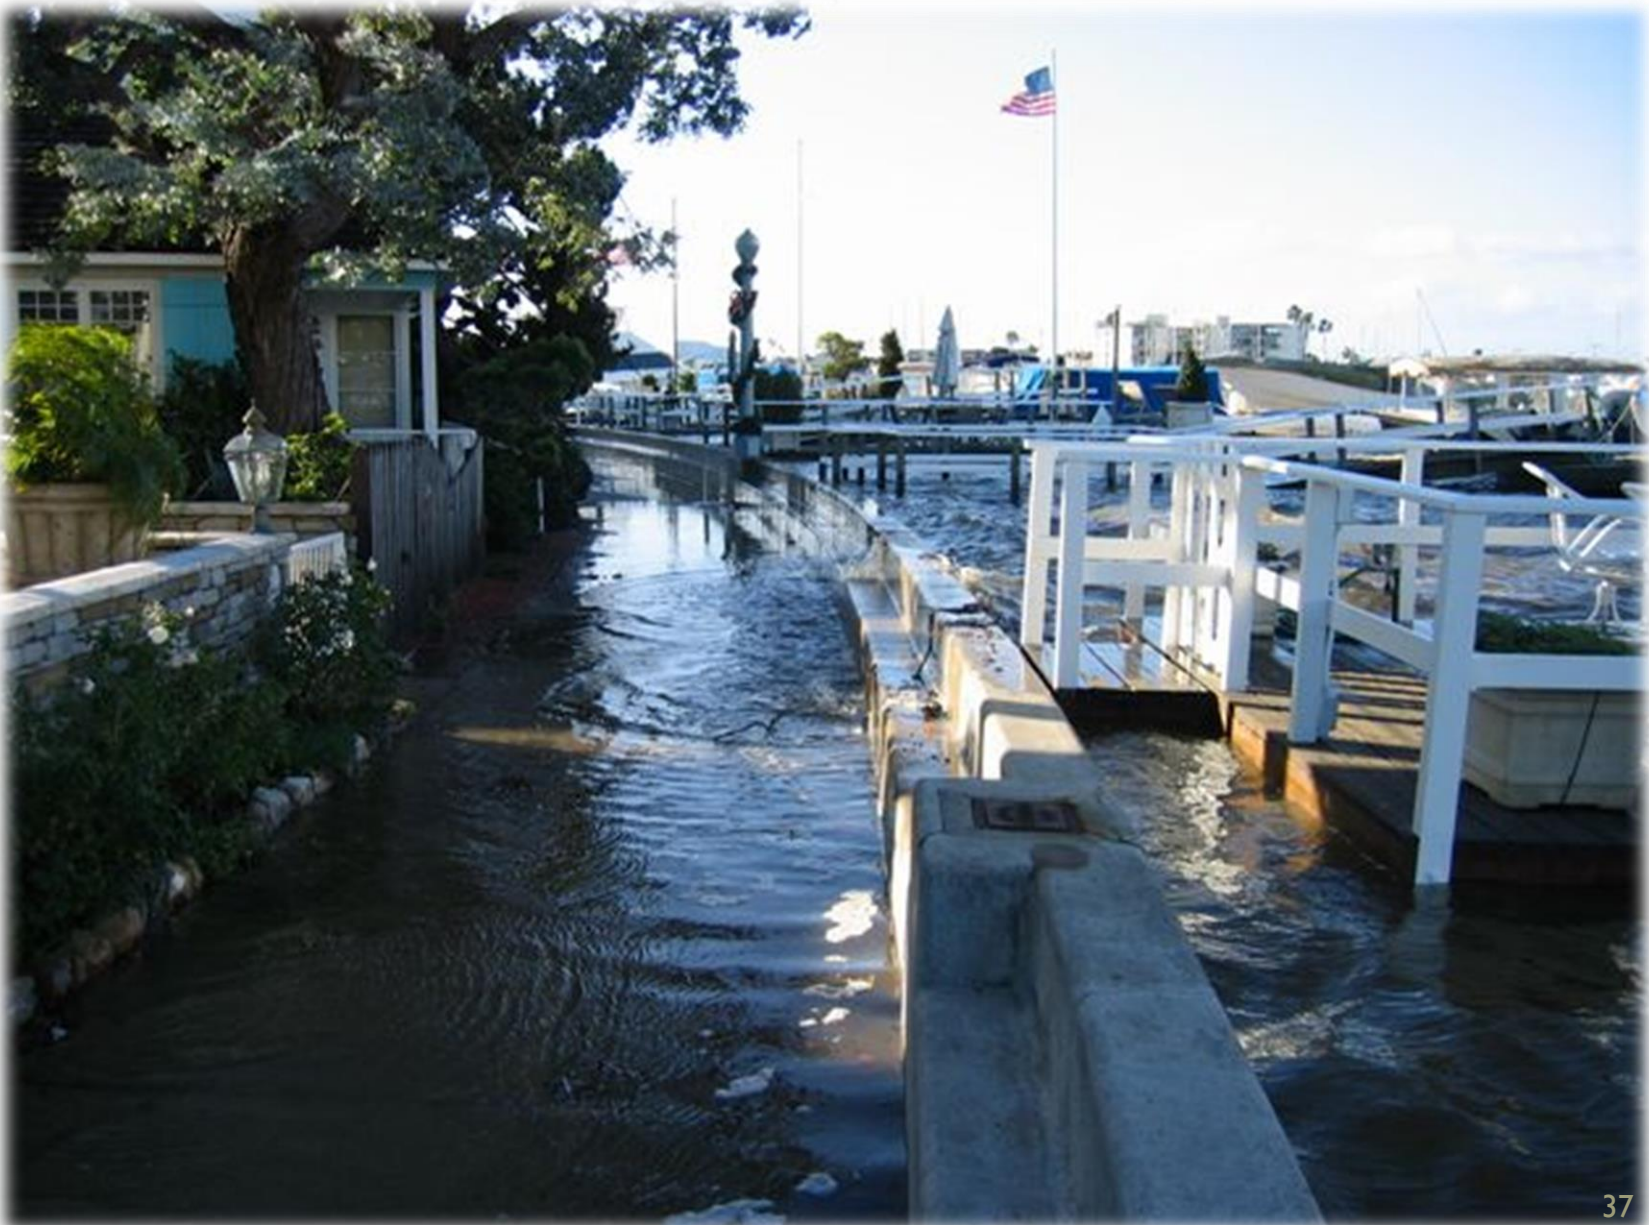
Wind Waves at High Tide (West End)

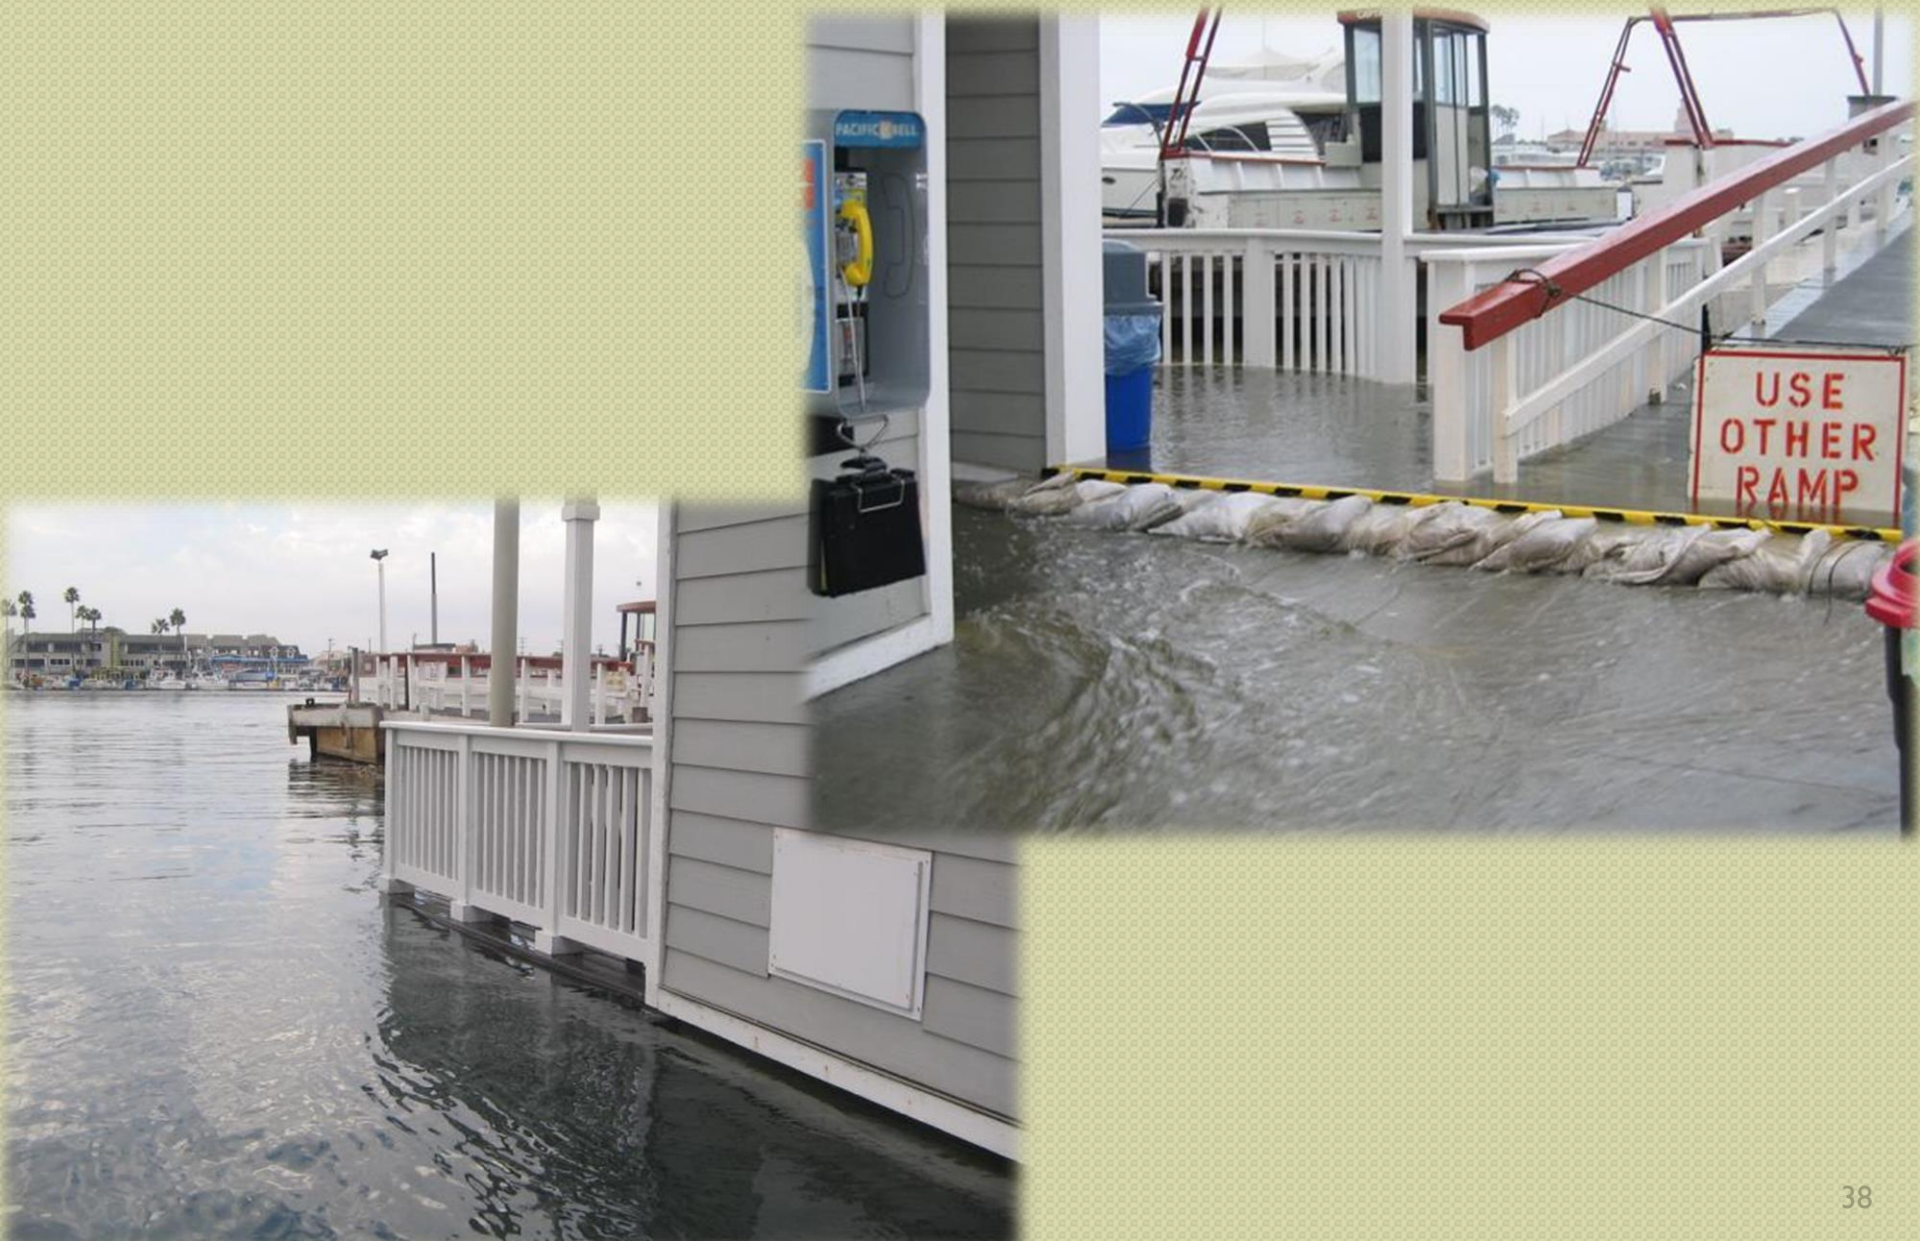
Flooding at Balboa Island Ferry Landing (2005)

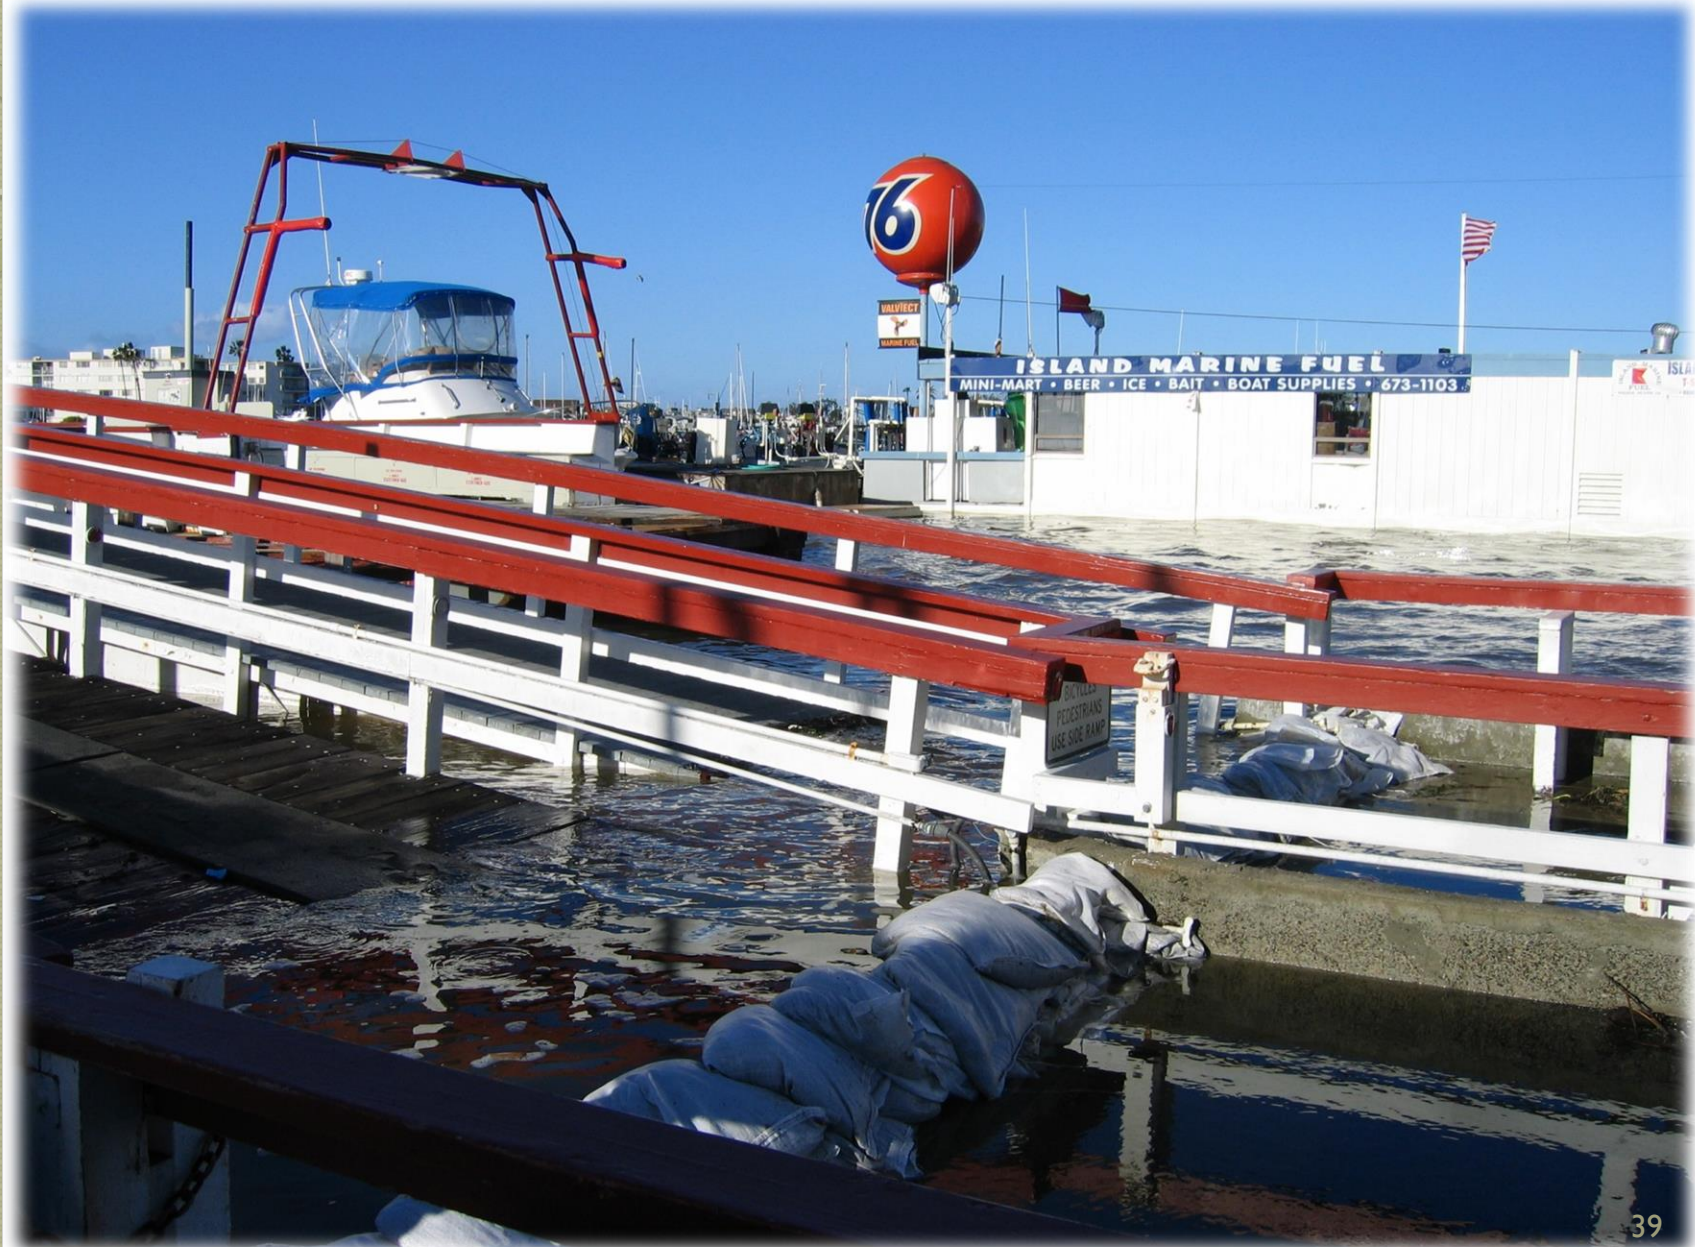
Flooding at Balboa Island Ferry Landing
